Retrofit Micropiles and SJ350 SmartJacks®

Project: Private Residence
Location: Montrose, CO
Date: August 2015

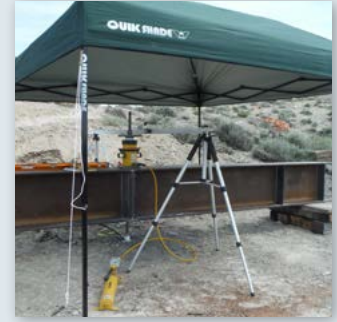
Tension test

The home would be supported by thirty-two (32) retrofit, grouted micropiles extending to depths below the expansive shale formation. The micropiles were designed to support a working load of 25 kips with a safety factor of 2.5. The micropiles would utilize Foundation Supportworks® Model 288 push pier brackets, external sleeves, and a prescribed, ten-foot length of pier tube around the upper grout column. Two tension load tests were performed in general accordance with the procedures defined in ASTM D3689 to verify capacities with acceptable deflections.

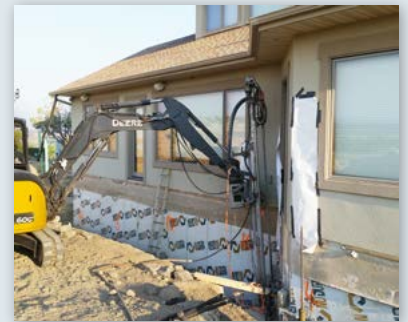
Drilling at micropile location

Concrete slabs and patios were removed and an excavation made along the entire perimeter of the foundation. Four-inch-diameter holes were drilled at each of the pier locations to specified depths from 30 to 36 feet below the footings with a rock drill mounted to a mini excavator. Retrofit brackets, external sleeves, and ten feet of pier tube were set at each pier location, and the drilled holes were filled by tremie grouting upwards from the bottom. Solid-bar reinforcement with centralizers was dropped through the bracket and pier tubes to the bottom of the hole. Once the grout had cured the minimum specified time of seven days, hydraulic cylinders were fitted to each of the brackets to uniformly lift the structure. The structure was lifted to within acceptable limits.

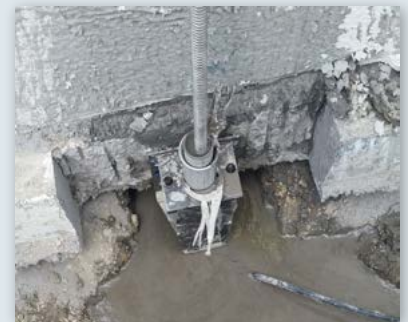
Grout-filled hole and pier tube

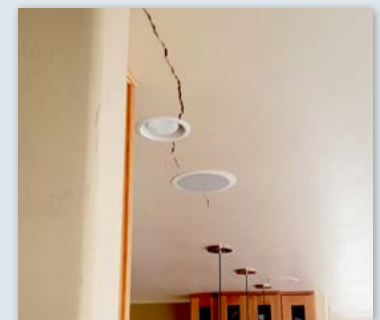
Excessive vertical movement of the 3,240 square-foot home caused doors and windows to stick and drywall to crack. A geotechnical investigation identified the house had been constructed over residual clays and shale bedrock. The expansive shale formation extended from basement elevation to 30 feet below the basement level footings. The homeowner wished to stabilize the home and lift the structure to create a void of at least four inches between the bottom of the existing footings and the original bearing soils.

Drywall crack in ceiling (before)

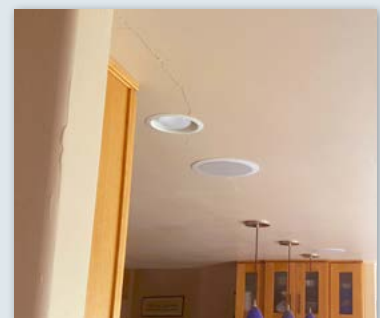
Drywall crack in ceiling (after)
