CASE STUDY

PowerBrace™ System

Project: Danielson Residence

Location: Danielson, CT

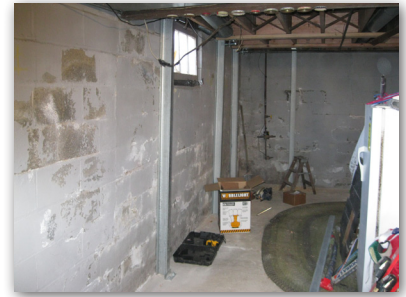
PowerBrace™ installed along north and west wall

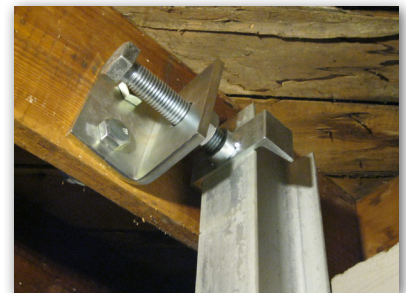
PowerBrace™ secured to floor joist

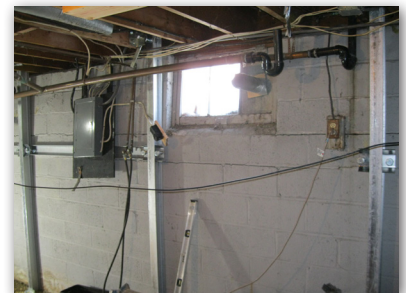
Installation around wall obstacles

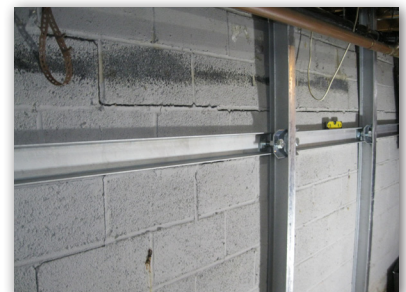
Cross-beam support on south wall
