PolyLevel®

Project: Northwest Park

Location: Davenport, IA

Date: May 2017

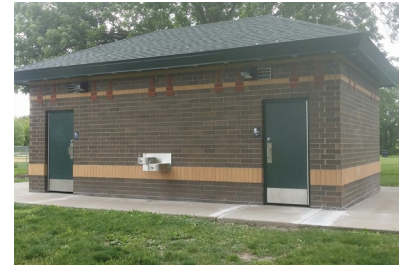
The sidewalk surrounding the public restroom building at Northwest Park in Davenport, Iowa experienced differential settlement, evident by faulted slab sections at some of the joints. This vertical displacement was as much as three inches, creating trip hazards and potential liability claims. The Parks and Recreation Department placed a concrete “wedge” at the worst location to minimize risk, but decided to seek a more suitable, long-term solution. Removal and replacement of the concrete was not considered since it would involve constructing barriers and shutting off access to the building for several days to a week.

Sidewalk settlement at public restroom

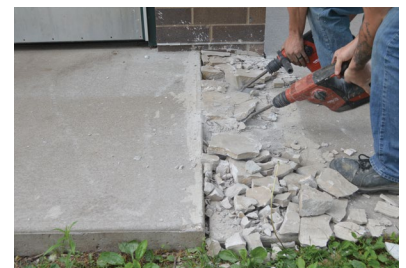
Removing concrete “wedge” prior to installing PolyLevel

MidAmerica Basement Systems proposed a slab stabilization and lift option using rigid polyurethane foam. Slab preparation included removing the concrete wedge and saw-cutting through the joints, where necessary, to prevent binding of the slabs during lift. PolyLevel 250 (PL250) was injected through penny-sized holes in the slabs strategically located on each side of the joints. PolyLevel is a rapidly setting, two-part liquid urethane that when combined expands in to a rigid foam used to fill voids, stabilize slabs and lift concrete. PL250 is extremely lightweight, with a typical in-place density of less than four pounds per cubic foot (pcf). Other void-filling or lifting materials can weigh upwards of 120 pcf, adding significant burden to supporting base materials and potentially contributing to further settlement. With a typical in-place compressive strength exceeding 5,000 pounds per square foot (psf), PL250 has more than enough strength to support residential and light commercial applications.

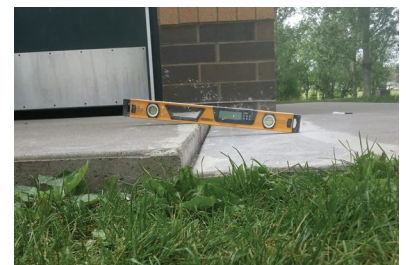
Three inches of differential settlement visible after concrete wedge removed

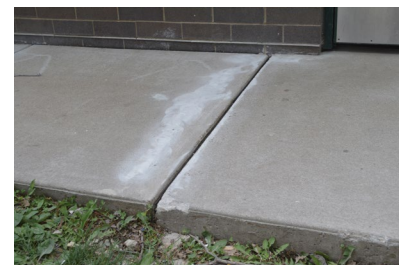
Faulted slab sections returned to original elevation

MidAmerica completed the entire job in just four hours using 126 pounds of PL250. The releveled sidewalk was returned to service immediately upon completion.
