FOUNDATION NATION

FSI NEWSLETTER FOR DESIGN PROFESSIONALS

Corrosion Considerations For Helical Pile Foundations

FSI NEWSLETTER FOR DESIGN PROFESSIONALS
 Quarterly Newsletter • Issue 6
 Winter 2011

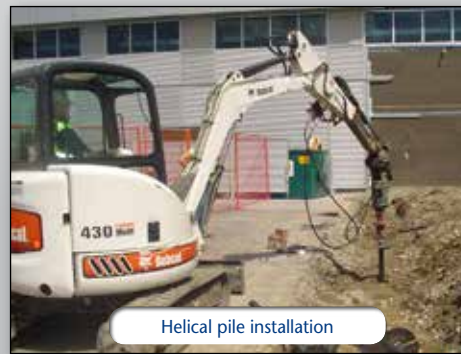
Project: Lone Star Mercedes Benz

Challenge: The Lone Star Mercedes Benz car dealership planned a renovation to their existing facility that included the construction of an approximate 1,000 square foot addition. A geotechnical investigation for the project included eight soil borings advanced to depths of 16.5 to 20 feet. The general subsurface profile consisted of 10 to 13 feet of uncontrolled fill, clayey silt with organics, over native silty sand with organics over dense sandy gravel. The dense sandy gravel layer was encountered at depths of 13 to 20 feet. The geotechnical engineer recommended against supporting the new addition with spread footings bearing within the uncontrolled fill. Over-excavation of the existing fill was also not an option due to the depth of fill and the potential for undermining the existing building and pavements without extensive shoring. Several deep foundation alternatives were considered with bearing within the dense gravel.

Solution: Helical piles were selected to support the new addition due to the relatively low (mobilization) costs compared to the other deep foundation alternatives. The smaller installation equipment could also access and maneuver more easily within the congested construction site. The foundation design for the addition included twenty-one new construction helical piles. Twelve retrofit helical piles were also installed along the foundation of the existing building to support load transferred from the addition. The helical piles were designed for a working load of 15 tons (30 kips). The helical pile configuration consisted of 2 7/8-inch O.D. by 0.276-inch wall round shaft with 10"-12" double-helix lead sections. At several pile locations extension sections with 14" helix blades were added in order to provide the torque-correlated soil capacity of at least twice the design working load ($FOS \geq 2$). From start to finish, the pile installation and all related prep and finish work were completed in 4 days and ahead of schedule.

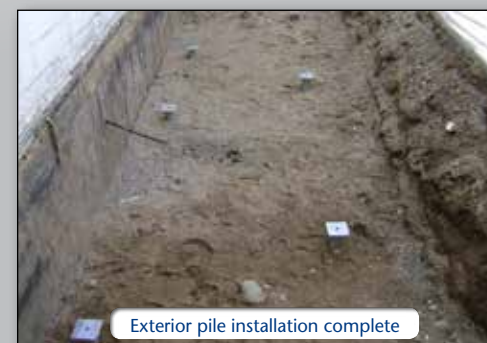
Project: Foremost Farms USA

Challenge: A \$3 million dryer addition was proposed with new foundations within and adjacent to an existing one-story building with basement. The basement floor slab of the existing building is approximately 15 feet below exterior grade. An interior pile cap was planned within the basement and an exterior pile cap was planned adjacent to the existing foundation wall. The two pile caps essentially created continuous support (although at different elevations) for a new foundation wall. The bottom of the exterior pile cap was 4 feet below grade to provide frost protection. With the new exterior pile cap abutting the foundation wall of the existing building, piles would have to be installed to depths below the existing footings to prevent excessive lateral loads from being applied to the existing basement wall. A geotechnical investigation included one soil boring to a depth of 30 feet. The boring encountered very loose to loose sand fill from the surface to 8 feet, over loose sand from 8 to 13 feet, over medium dense sand from 13 to 30 feet.

Solution: Several deep foundation systems were considered, but helical piles were selected as the ideal option given the limited access to the interior pile locations and the ability to quickly mobilize equipment and product to the job site. The foundation design included two helical pile configurations. Eleven Model 287 (2 7/8-inch OD by 0.203-inch wall) round shaft helical piles with 10"-12" double-helix lead sections were included to support the design working load of 10 kips per pile, and three Model 288 (2 7/8-inch OD by 0.276-inch wall) round shaft piles with 10"-12"-14" triple-helix lead sections were included to support the design working load of 22.5 kips per pile. Seven piles were installed on the inside of the building and seven piles were installed on the outside. The exterior piles closest to the existing foundation wall were installed so the uppermost helix blades were at least 3 feet below the existing footings. The piles were installed to torque values of at least 2,300 ft-lb (Model 287) and 5,000 ft-lb (Model 288) to provide correlated ultimate soil capacities of at least two times the design working loads ($FOS \geq 2$). Foundation Supportworks of Wisconsin installed the 14 piles in one day to depths ranging from 15 to 26.5 feet.

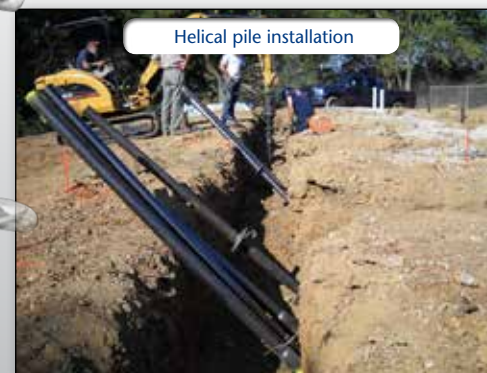
Project: Lion and Baboon Exhibit

Challenge: The proposed site for the new Knoxville Zoo Lion and Baboon Exhibit was within a previously developed area of the property. The six test borings completed for the project encountered undocumented fill to depths ranging from 11 to 17 feet. The fill was primarily described as silty clay with rock fragments, although isolated pieces of debris and trash were also observed. Standard penetration test blow counts (N-values) within the fill ranged from 2 to 14 blows per foot. The fill is underlain by residual silty clay and bedrock. The test borings refused on apparent limestone layers at depths of 11 to 23.5 feet. The geotechnical engineer recommended that the exhibit be supported by deep foundations extending down to the bedrock surface. Design working loads for the 56 piles ranged from 20 to 70 kips, but were mostly in the range of 20 to 50 kips.

Solution: Helical pile foundations were selected to extend through the fill and native residual soils for bearing on or within the limestone bedrock. The piles would likely "spin-off" on top of the hard bedrock surface rather than cut into the material with the helix blades and develop a torque to capacity correlation. The allowable mechanical capacity of the pile shaft was therefore considered in the pile selection. The foundation design included 37 Model 288 (2.875-inch O.D. by 0.276-inch wall) and 19 Model 350 (3.5-inch O.D. by 0.313-inch wall) round shaft helical piles. All piles had an 8"-10" double-helix lead section with the 8-inch blade being 1/2-inch thick and a special order V-style cut. The beveled tips of the lead sections were cut off straight to allow for better end bearing of the shaft on the bedrock surface. The 56 piles were installed to depths ranging from 8 to 33 feet. The pile installation was completed in three days.
