## Model 288 Helical Piles

**Project:** Central Decatur School Renovation Project

**Location:** Leon, IA

**Date:** June 2009

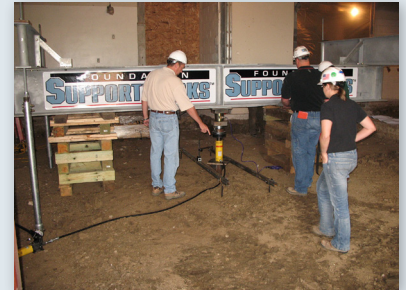
Load test set up prior to installation of performance piles

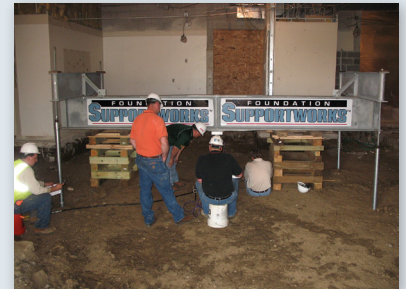
Load test completed and design capacities confirmed

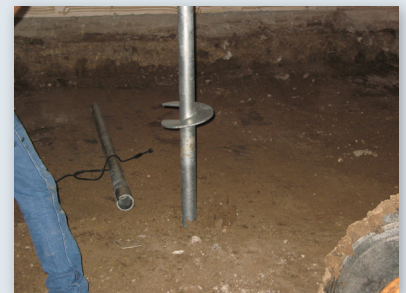
Helix lead sections are advanced through hard, dry to damp fill soil layers

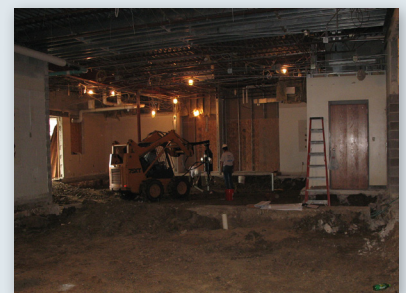
Piles are installed in limited access areas within the building using small construction equipment
