FOUNDATION NATION

FSI NEWSLETTER FOR DESIGN PROFESSIONALS

The Difference is in the Details: Coupler Details

FSI NEWSLETTER FOR DESIGN PROFESSIONALS
Quarterly Newsletter • Issue 5
Fall/Winter 2010

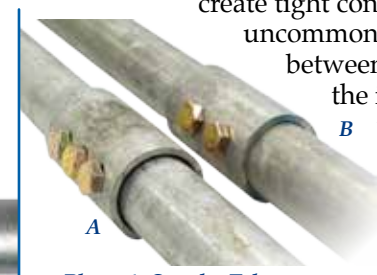
Photo 4: Coupler Tolerances; (A) Competitor Upset Coupler, (B) FSI External Welded Coupler

create tight connections to strict tolerances. It is not uncommon to have 1/8-inch or more difference between the outside diameter of the shaft and the inside diameter of the upset coupler of the round shaft (See Photo 4). Again, the greater the freedom allowed in the connection, the greater the potential variance from straightness and the higher the potential for bending or buckling of the pile under high compressive loads (See Photo 5). The risk of pile buckling further increases with unsupported lengths above the ground surface, or if the pile extends through soil strata consisting

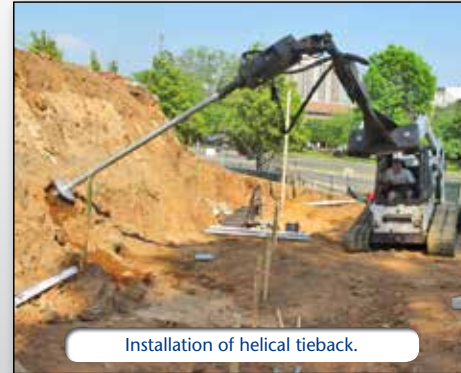
Installation of helical tieback.

Solution: A new cast-in-place concrete retaining wall was designed with helical tiebacks to resist the lateral forces. The design included two rows of tiebacks; eleven (11) near the top of the wall with an 8-foot spacing and an installation angle of 30 degrees downward from horizontal, and eighteen (18) near the bottom of the wall with 4, 5, and 6-foot spacings and a horizontal orientation. Design working loads for the angled and horizontal tiebacks were 40 kips and 37.5 kips, respectively. The helical tieback configuration consisted of 3 1/2-inch OD round shaft with 10"-12"-14" triple-helix lead sections. The angled and horizontal tiebacks were installed to torque values of at least 8,600 ft-lb and 8,000 ft-lb, respectively, to provide torque-correlated ultimate capacities of at least 1.5 times the design working loads. Due to the soil variability, the tiebacks were advanced to lengths ranging from 17 to 46 feet in order to achieve the target torque values. The correlation between installation torque and ultimate capacity was verified with two load tests. One retrofit helical pier was also installed to vertically support the footing of an existing block wall against undermining and settlement at the connection to the new wall. The pier configuration consisted of a 2 7/8-inch OD round shaft with a 10"-12" lead section. The pier was installed to a depth of 14 feet and to a torque-correlated ultimate capacity of 30 kips for a factor of safety of 2.

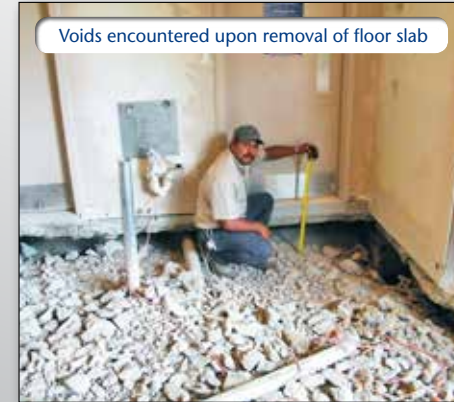
voids encountered upon removal of floor slab

During the demolition phase of the contract, JES encountered unforeseen conditions in the lobby area and near the main stage. A 10-inch void was encountered beneath the lobby area floor slab and the foundation wall at the stage had settled approximately 1 inch. To resolve these unforeseen conditions, a contract modification was executed to install eighteen (18) hydraulically-driven slab piers in the lobby area and three (3) hydraulically-driven foundation piers at the main stage. The void beneath the pier-supported lobby slab was then filled with cement grout.

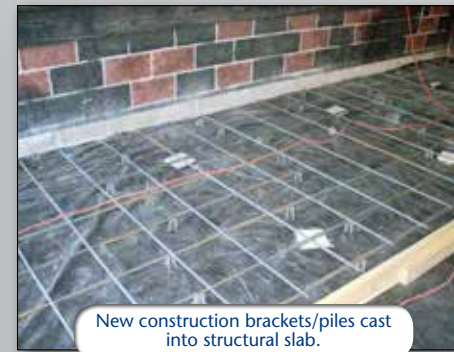
New construction brackets/piles cast into structural slab.

Solution: JES Construction, Inc. (JES) was awarded the design-build project with the general scope of work to include; partial demolition of the existing concrete slab, installation of helical piles and a new structurally-reinforced concrete slab, construction of a new wheelchair seating area, and incidental carpentry repairs. Fifty-eight (58) helical piles were installed within the 45-foot by 60-foot auditorium. The pile configuration consisted of 2 7/8-inch OD by 0.203-inch wall round shaft with 8"-10" double-helix leads. The helical piles were installed to an average depth of 45 feet to support the design working load of 15 kips. The structural slab was detailed at 5 inches thick (3,000 psi) with No. 4 rebar at 12 inches on center each way and a maximum pile grid spacing of 8 feet.

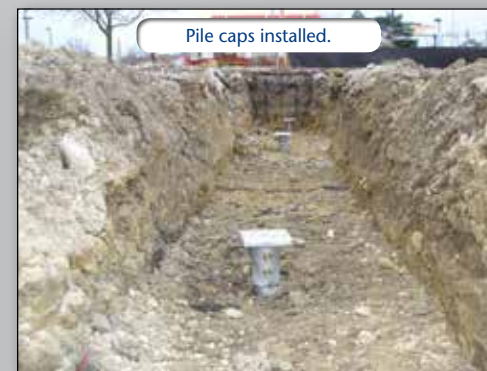
Pile caps installed.

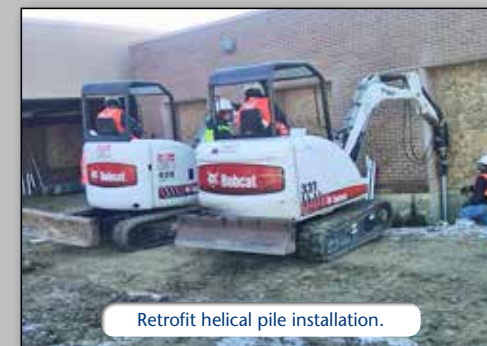
Retrofit helical pile installation.

Solution: Helical piles were selected to penetrate the upper fill and residual soils for end-bearing within the bedrock. Helical piles proved to be the most cost-effective approach, partly due to the relatively low mobilization costs compared to other deep foundation alternatives. The smaller installation equipment could also access and maneuver more easily within the congested construction site. The foundation design for the new additions included twenty-one new construction helical piles. Twelve retro-fit helical piles were also proposed to support and stabilize the existing structure against further settlement. The helical piles were designed for a working load of 15 tons (30 kips). The helical pile configuration consisted of 2 7/8-inch OD by 0.276-inch wide round shaft with an 8-inch diameter, single-helix lead section. Standard extensions were used to advance the piles to depths ranging from 18 to 23 feet. The pile installation and all related prep and finish work were completed in 4 days and ahead of schedule, even with exterior temperatures reaching negative twelve (-12) degrees Fahrenheit.
