## Model 288 Retrofit Helical Piers

**Project:** Royal Estates Apartment Complex  
**Location:** Jacksonville, FL  
**Date:** June 2013

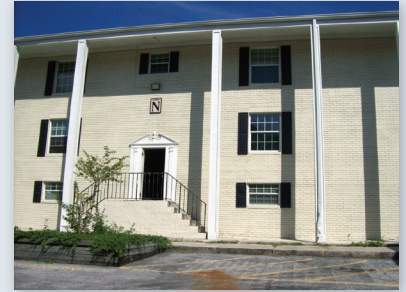
One of the six buildings to be stabilized

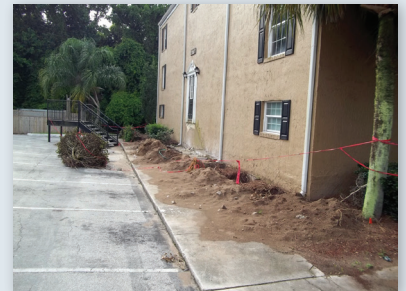
Preparing work area for pier installations

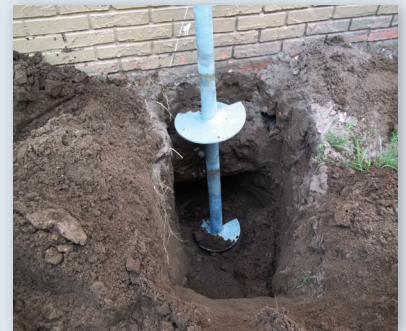
Advancing lead section

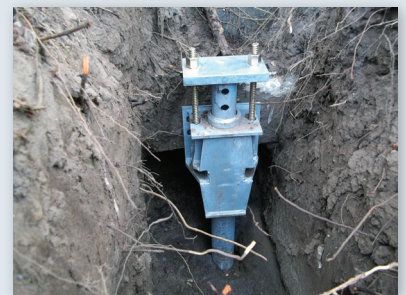
Pier installation complete

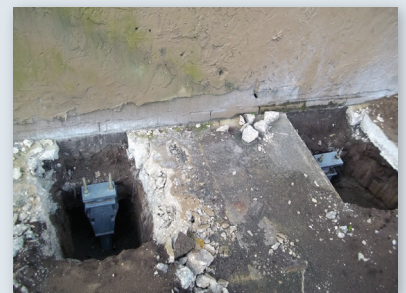
Pier installation complete
